MODELS 199

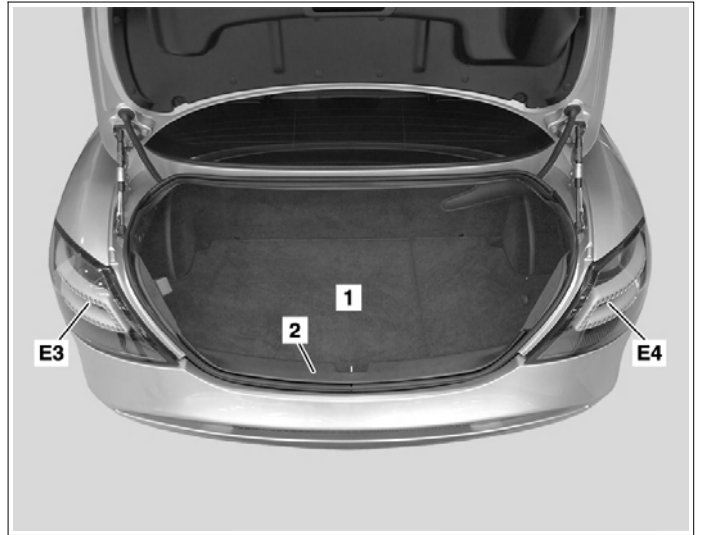
P82.10-3513-11

- 1 Floor mat
- 2 Cover
- E3 Left taillamp
- E4 Right taillamp

Remove/Install		
1	Remove floor covering (1) from luggage compartment		
202 sensor downstream of TWC [KAT]	Remove cover (2).		
3	Remove side paneling in trunk		AR68.30-P-4800SLR
4	Detach tie strap (3)	i Installation: replace tie straps (3).	
5	Unplug connector (6)		
6	Unscrew nuts (4)		
7	Remove right taillamp (E4) or left taillamp (E3)	i Installation: Ensure that the grommet (5) is seated properly in the cable duct.	
8	Install in the reverse order

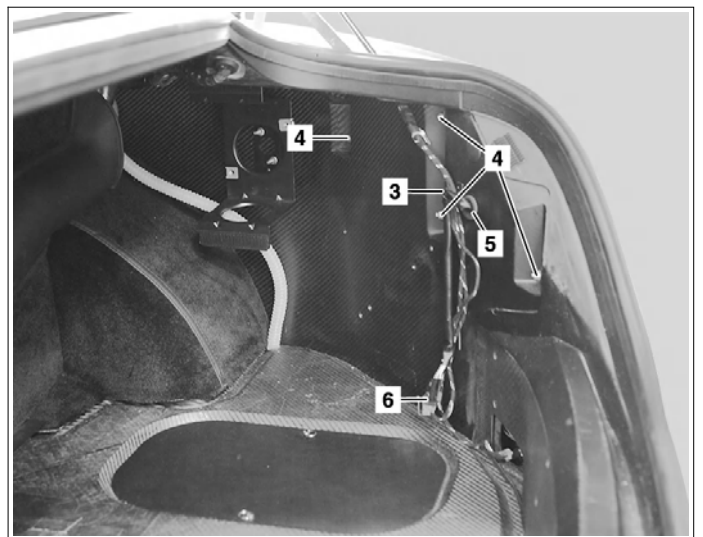
P82.10-3514-11

- 3 Tie strap
- 4 Nuts
- 5 Rubber grommet
- 6 Plug connection

Shown on right side

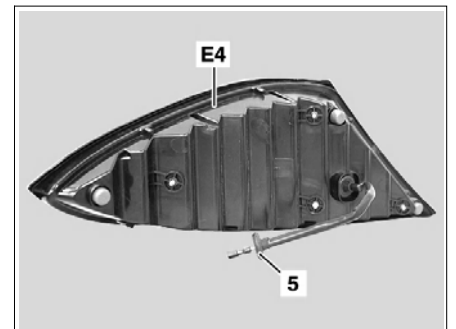
P82.10-3515-01

- 5 Rubber grommet
- E4 Right taillamp
